SUCCESS STORIES FROM THE FIELD

City of Thomas

Building a Vacant & Dilapidated Building Inventory

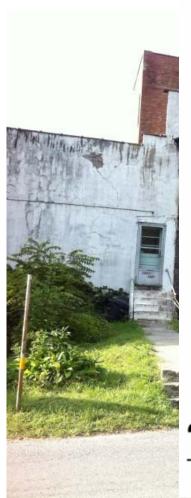
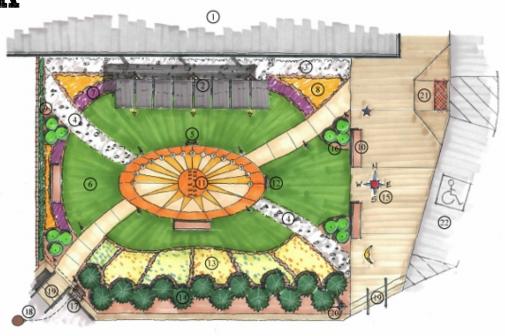
HELIOS PARK

- Initially 6 solar panels will be installed, with room to expand to 8.
 The human sundial is to be constructed of pervious pavers, or colored pervious concrete, to help minimize site runoff.
- The dry laid stream to be constructed with river stone, or recycled colored crushed glass.
- The existing privacy fence to be screened with a climbing flowering vine or espaliered flowering trees.
- Sidewalk murals to be painted using volunteer labor, such as local school children or boy scouts.
- New ADA-compliant handrails are to be installed on the existing
